CASE STUDY **HYUNDAI – ATLAS** **MAXI 100** **INCINERATOR** **REFURBISHMENT**

All refractories and insulation replaced internally

Hyundai – ATLAS Maxi 100 – Incinerator refurbishment

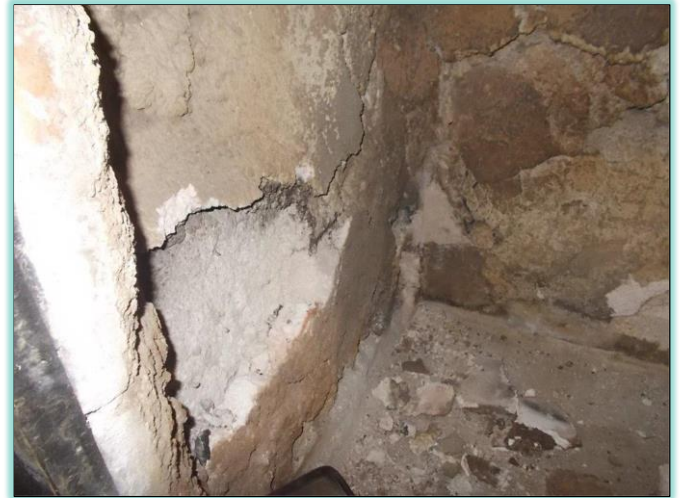
After a long service life, the internal condition was found quite miserable and in need of extensive repairs to assure trouble free operation and avoid possible damage to the steel casing and cooling cap around the incinerator furnace. A full replacement was proposed and accepted by owners.

Internal condition found quite miserable

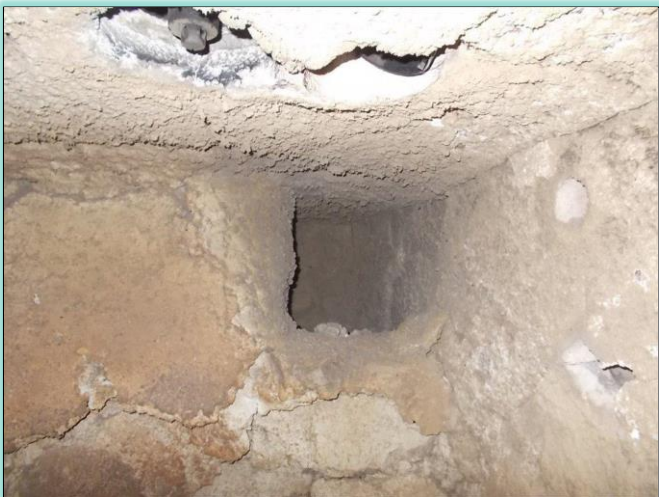
Dividing wall to second chamber found close to collapsing (note burners in roof)

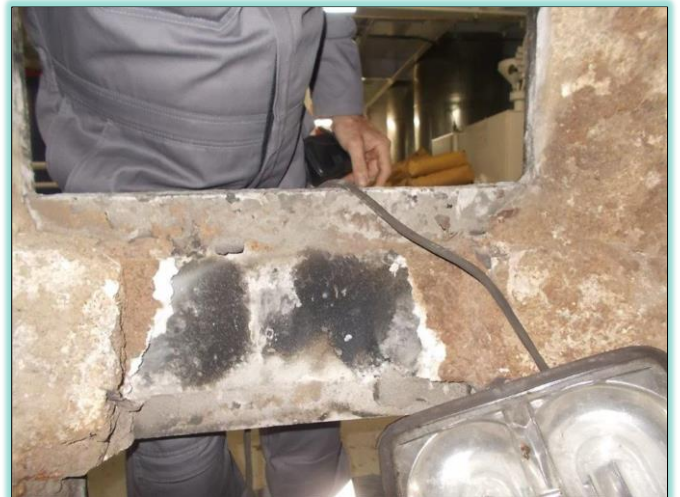
Front wall casing disposed to the heat with risk of damage

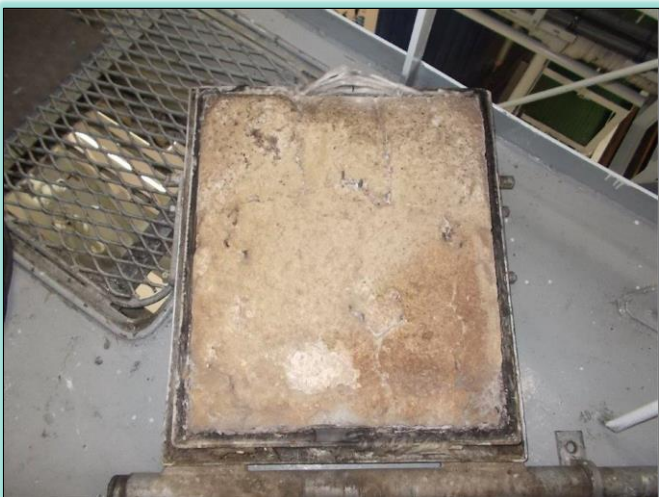
Doors found in very poor conditon
