CASE STUDY **HYUNDAI – ATLAS** **MAXI 100** **INCINERATOR** **REFURBISHMENT**

All refractories and insulation replaced internally

Hyundai – ATLAS Maxi 100 – Incinerator refurbishment

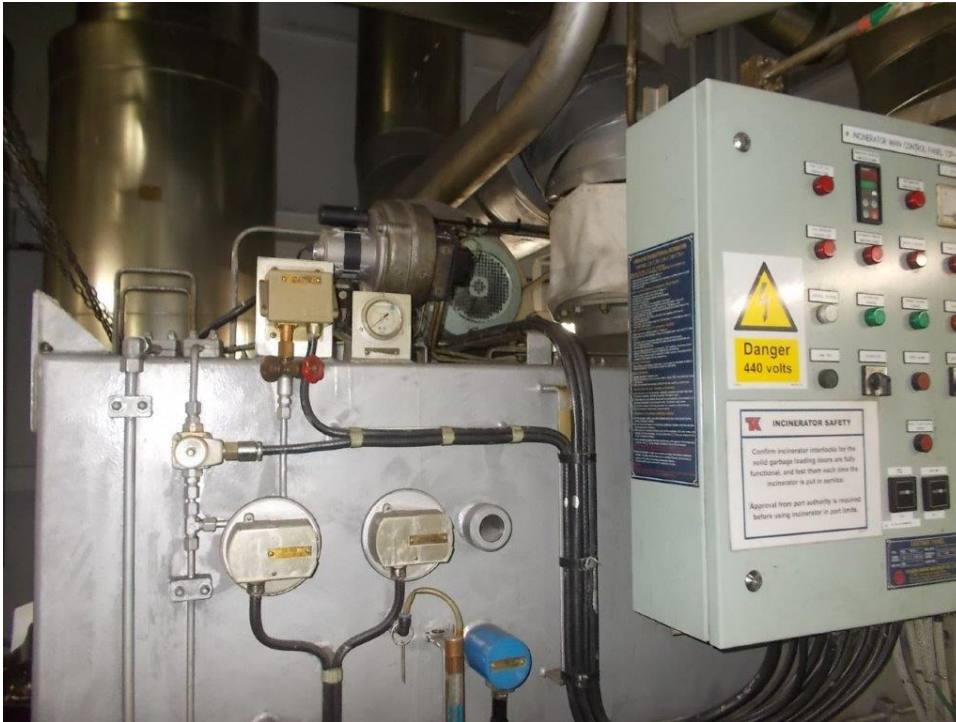
After a long service life, the internal condition was found quite miserable and in need of extensive repairs to assure trouble free operation and avoid possible damage to the steel casing and cooling cap around the incinerator furnace. A full replacement was proposed and accepted by owners.
